PBY Catalina

Walk Around

By William Scarborough

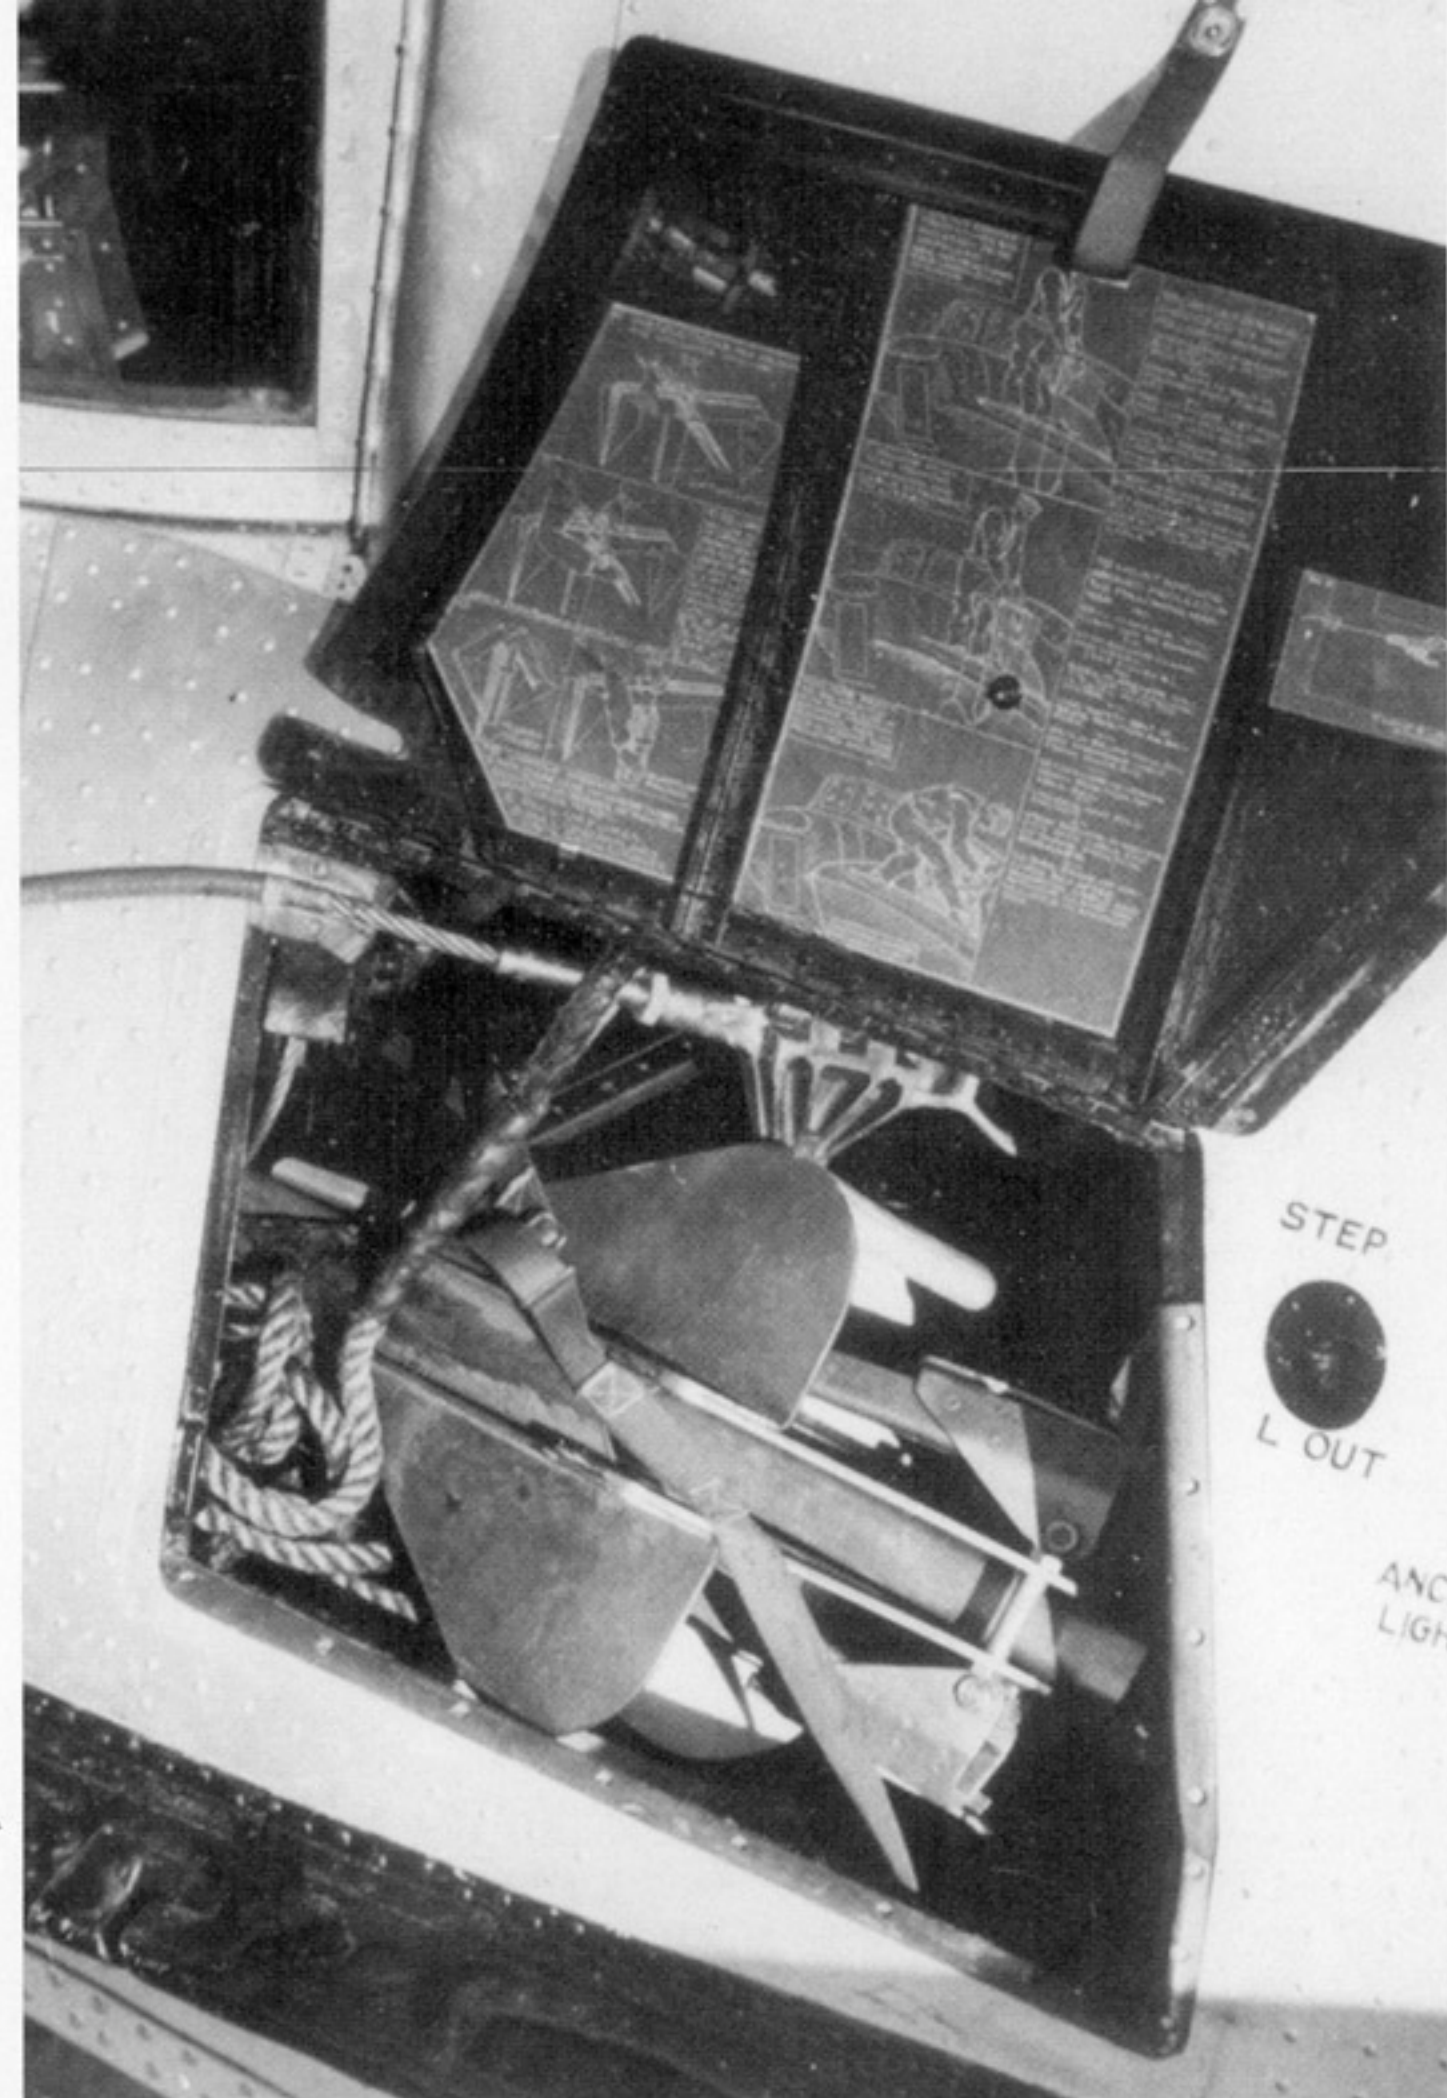
The anchor was stowed in a compartment located on the port side of the bow near the bow turret of all PBY variants. The PBY-5 and later models carried a smaller anchor of the same type. Operating instructions were carried on the inside of the compartment door. (CAC)

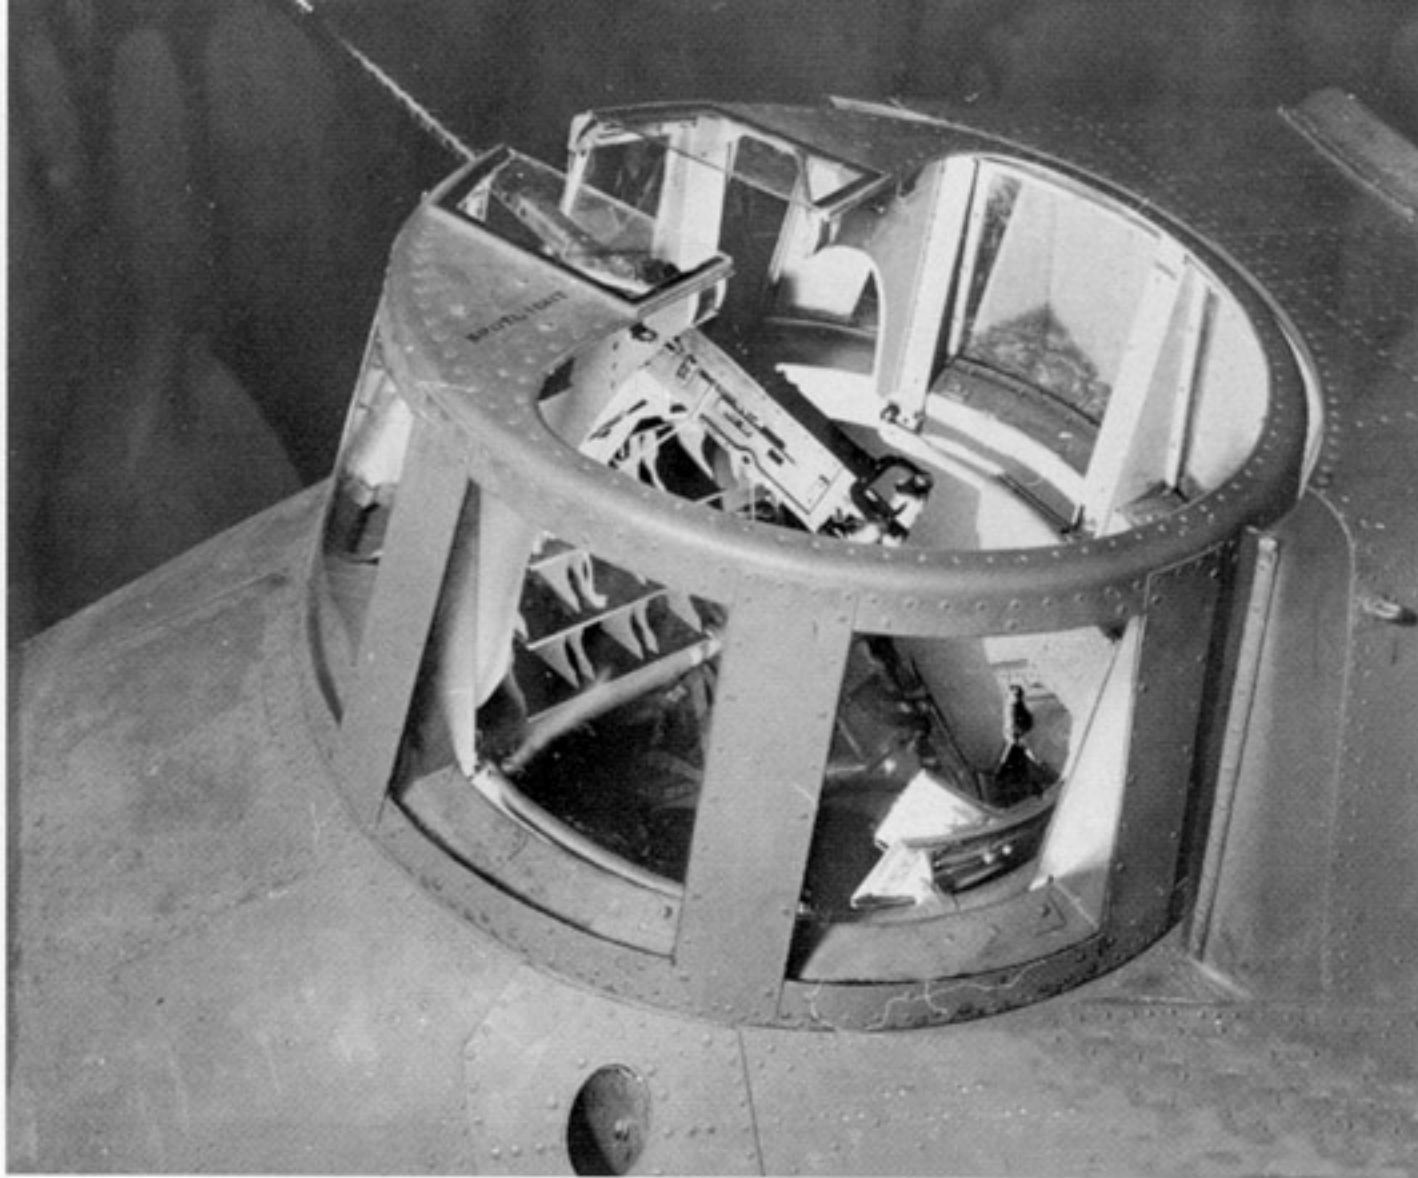
The bow gun turret of a early production PBY-5 during 1940/41. The turret was armed with a single .30 caliber air cooled machine gun. Belted ammunition for the gun was in 100 round magazines (ammo cans) in the rack visible under the gun. The socket below the gun turret was used for mounting the removable snubbing post. (CAC)

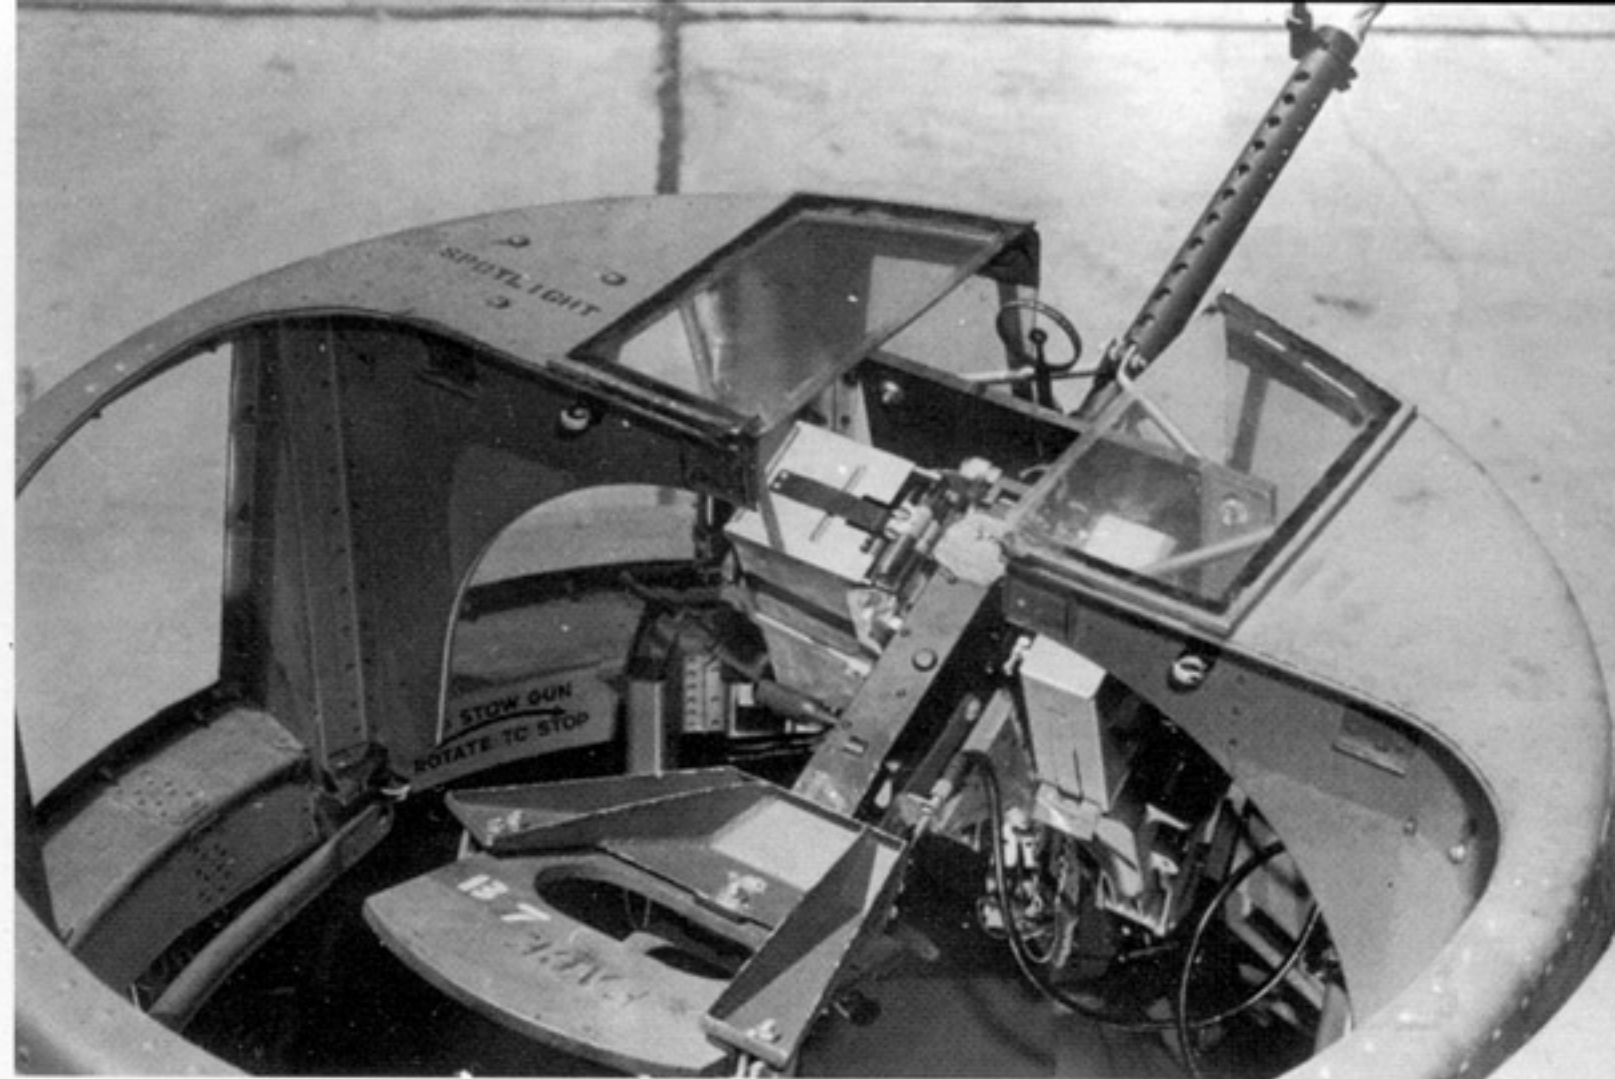
This bow turret was installed on a USAAF OA-10 during 1942/43. The turret was still armed with a single Browning .30 caliber machine gun, but the mounting was modified to provide some armor protection for the gunner. This same turret was also used on the PBY-5 and PBY-5A. (CAC via Lucabaugh)

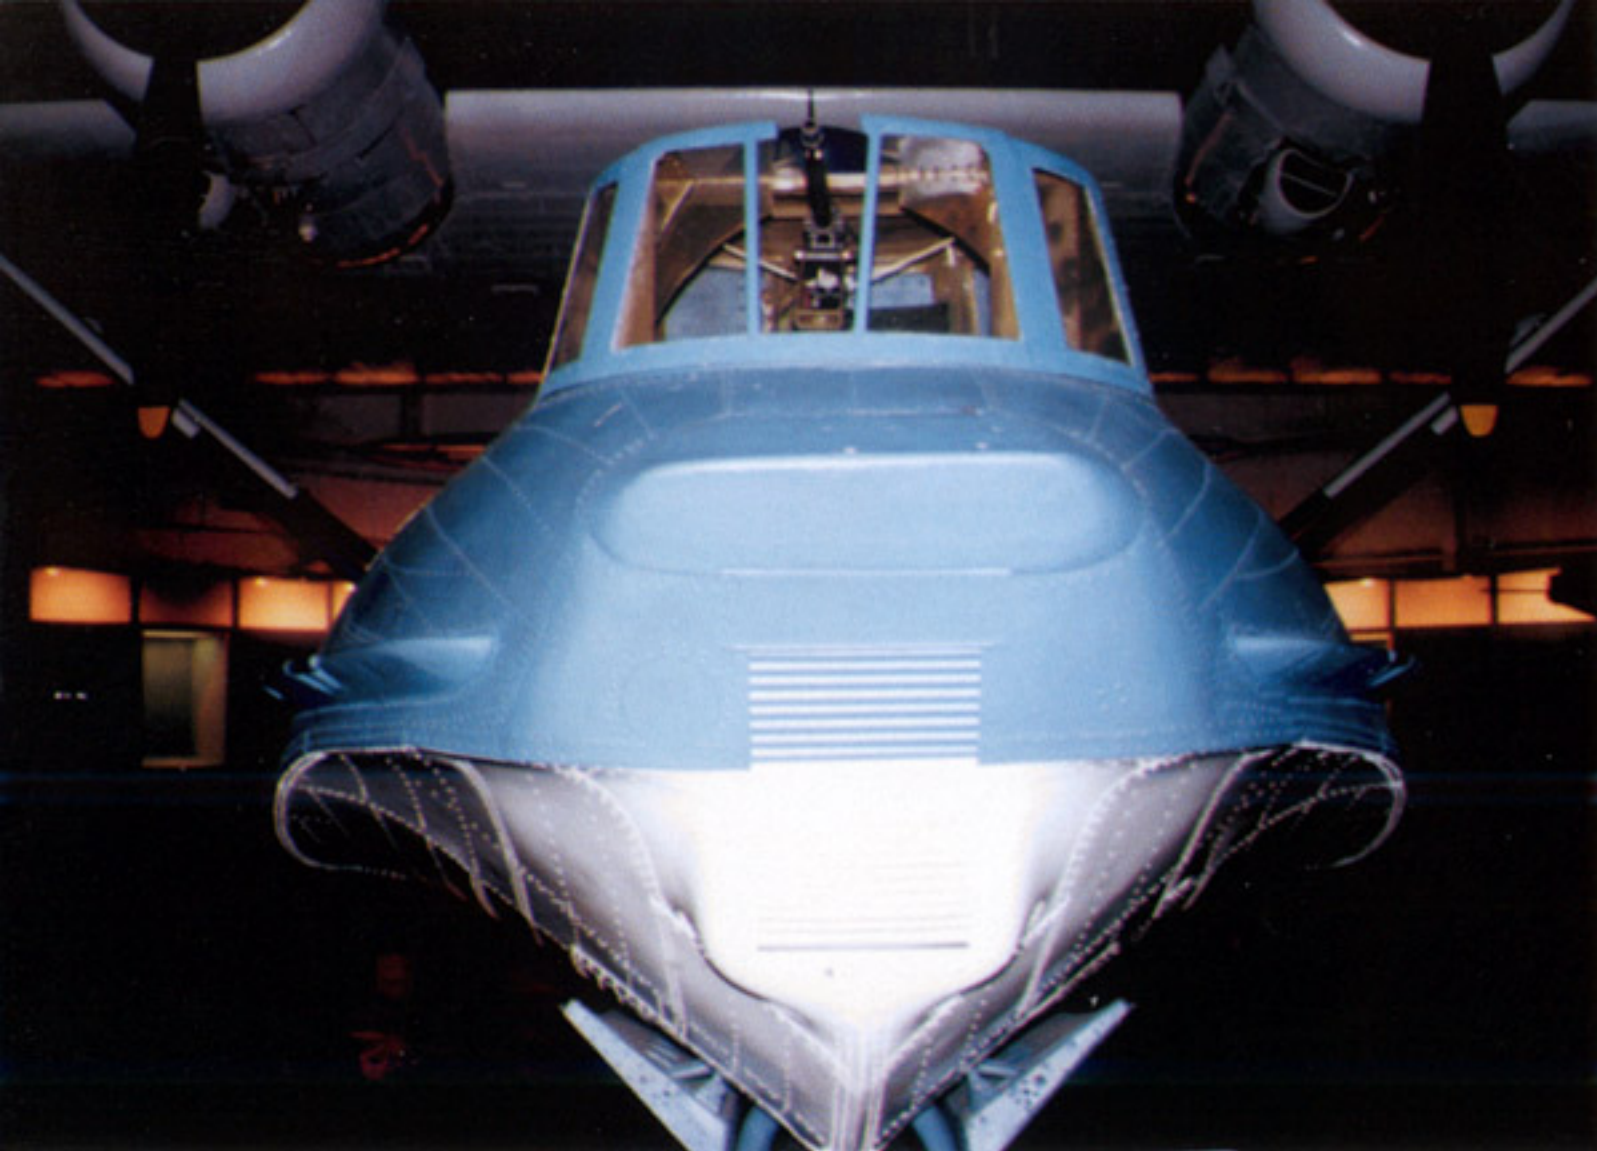
The nose of an OA-10A (PB5Y-5A). The nose wheel doors are visible at the bottom. The bombing window in the center is covered over by a retractable shutter for protection. On either side of the hull are the chine rails, which are used as a work platform by crewmen when mooring the Catalina. This aircraft has an early style bow turret with a single .30 caliber machine gun. (B. Ryle)

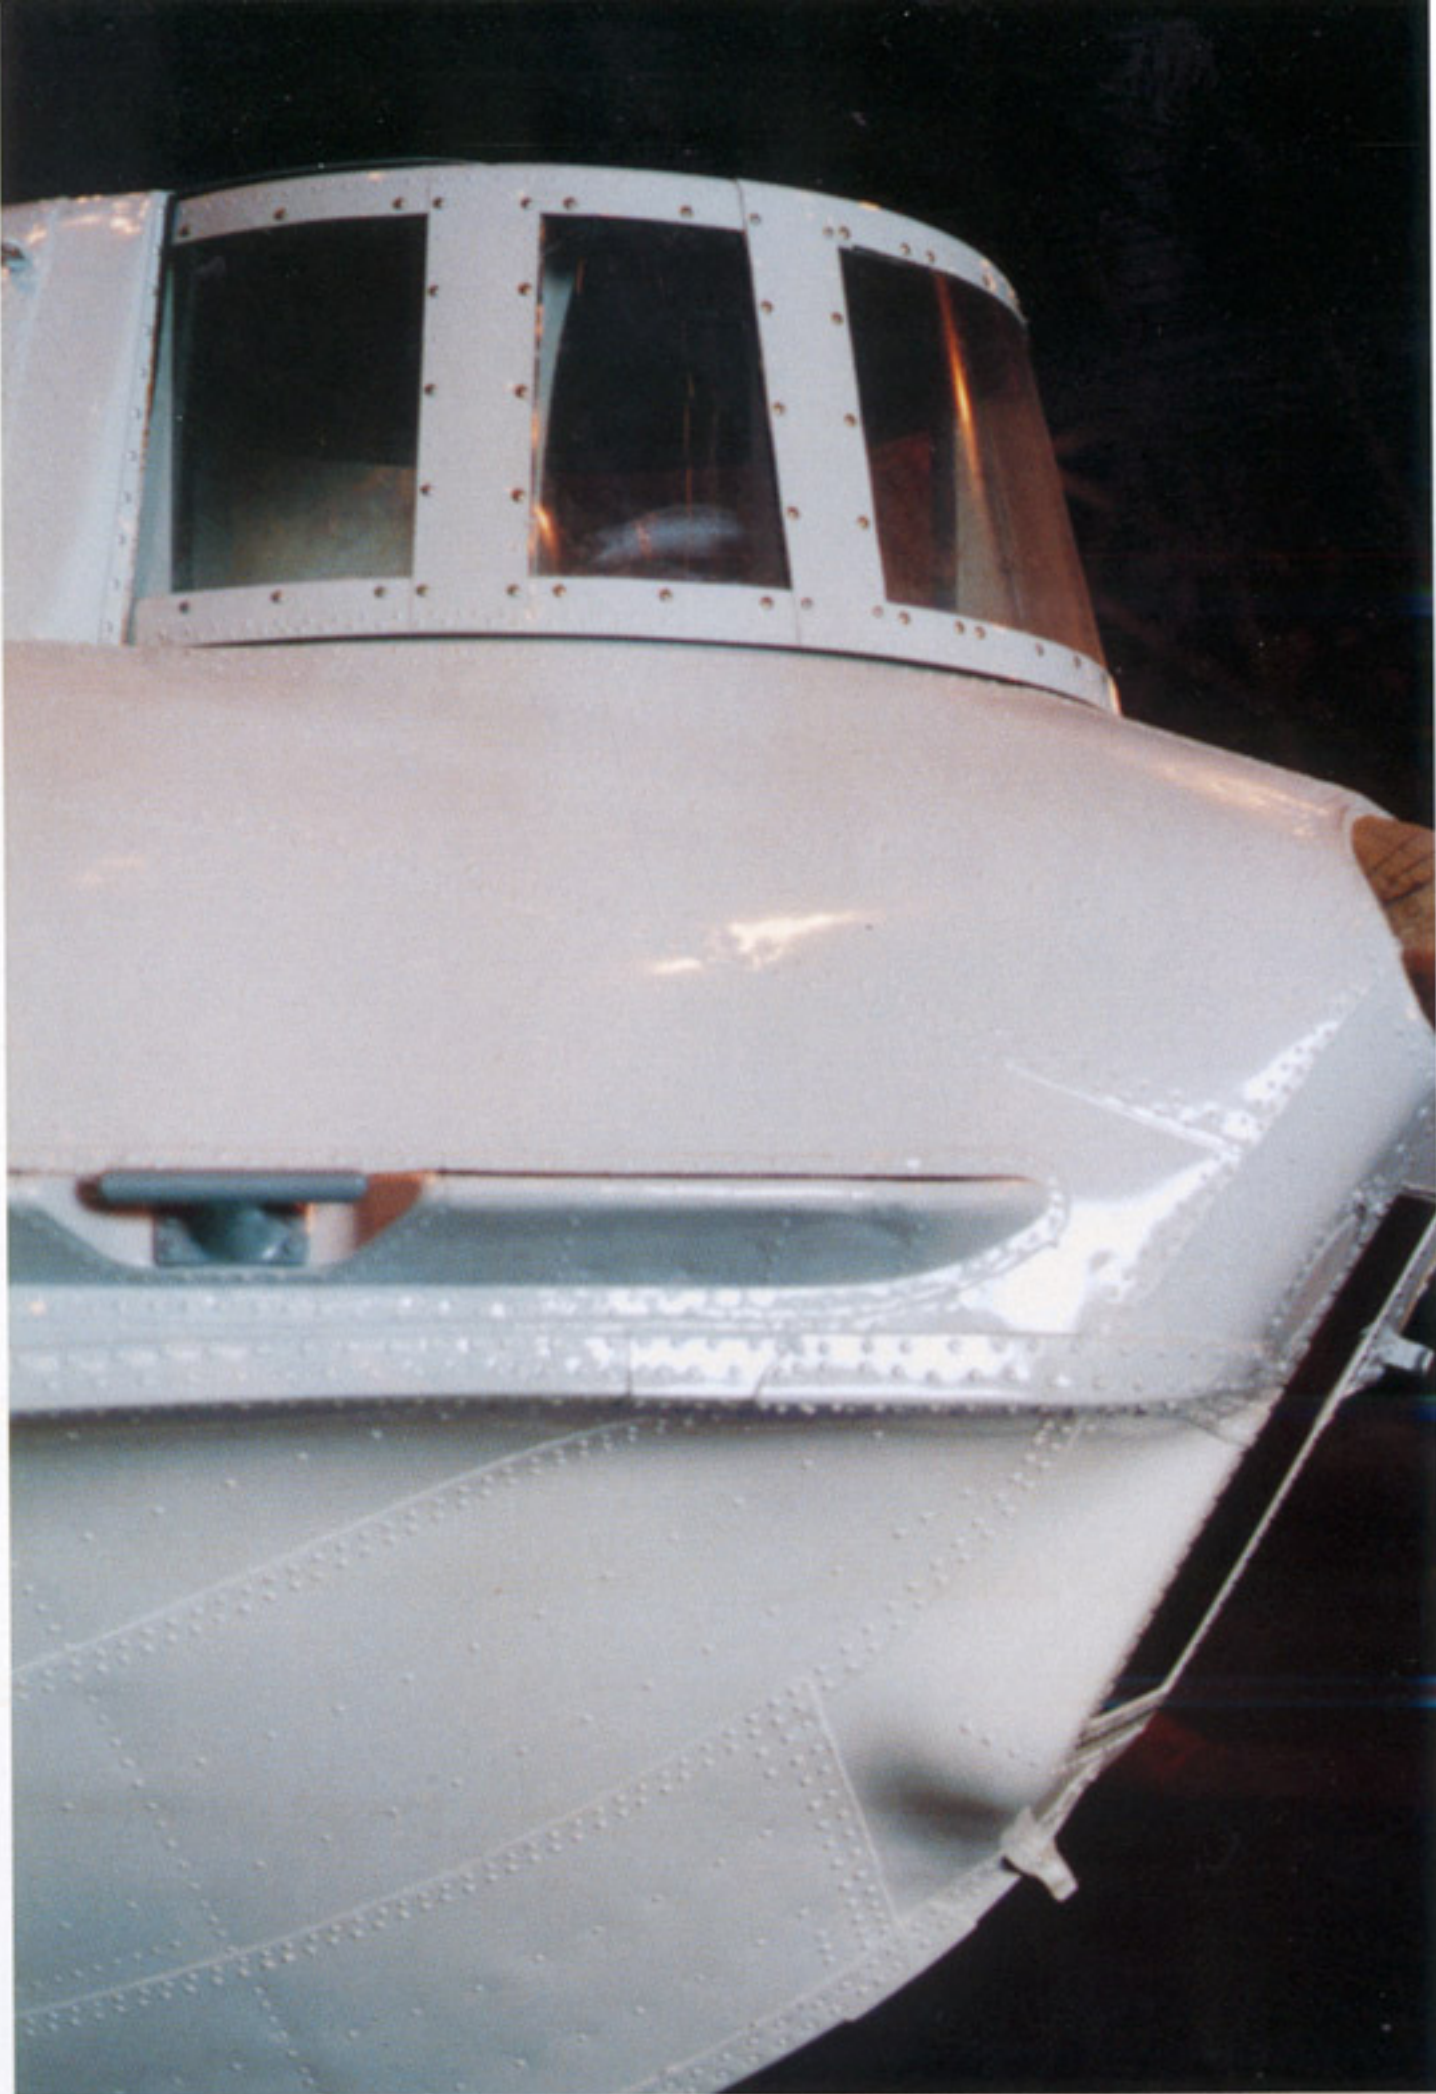
The bow turret could rotate over ninety degrees to either side before being blocked by the fuselage. The front center panel of the turret, through which the gun barrel normally extended for firing, could be covered with a removable panel whenever the gun was in the stowed position. (Mark Aldrich)

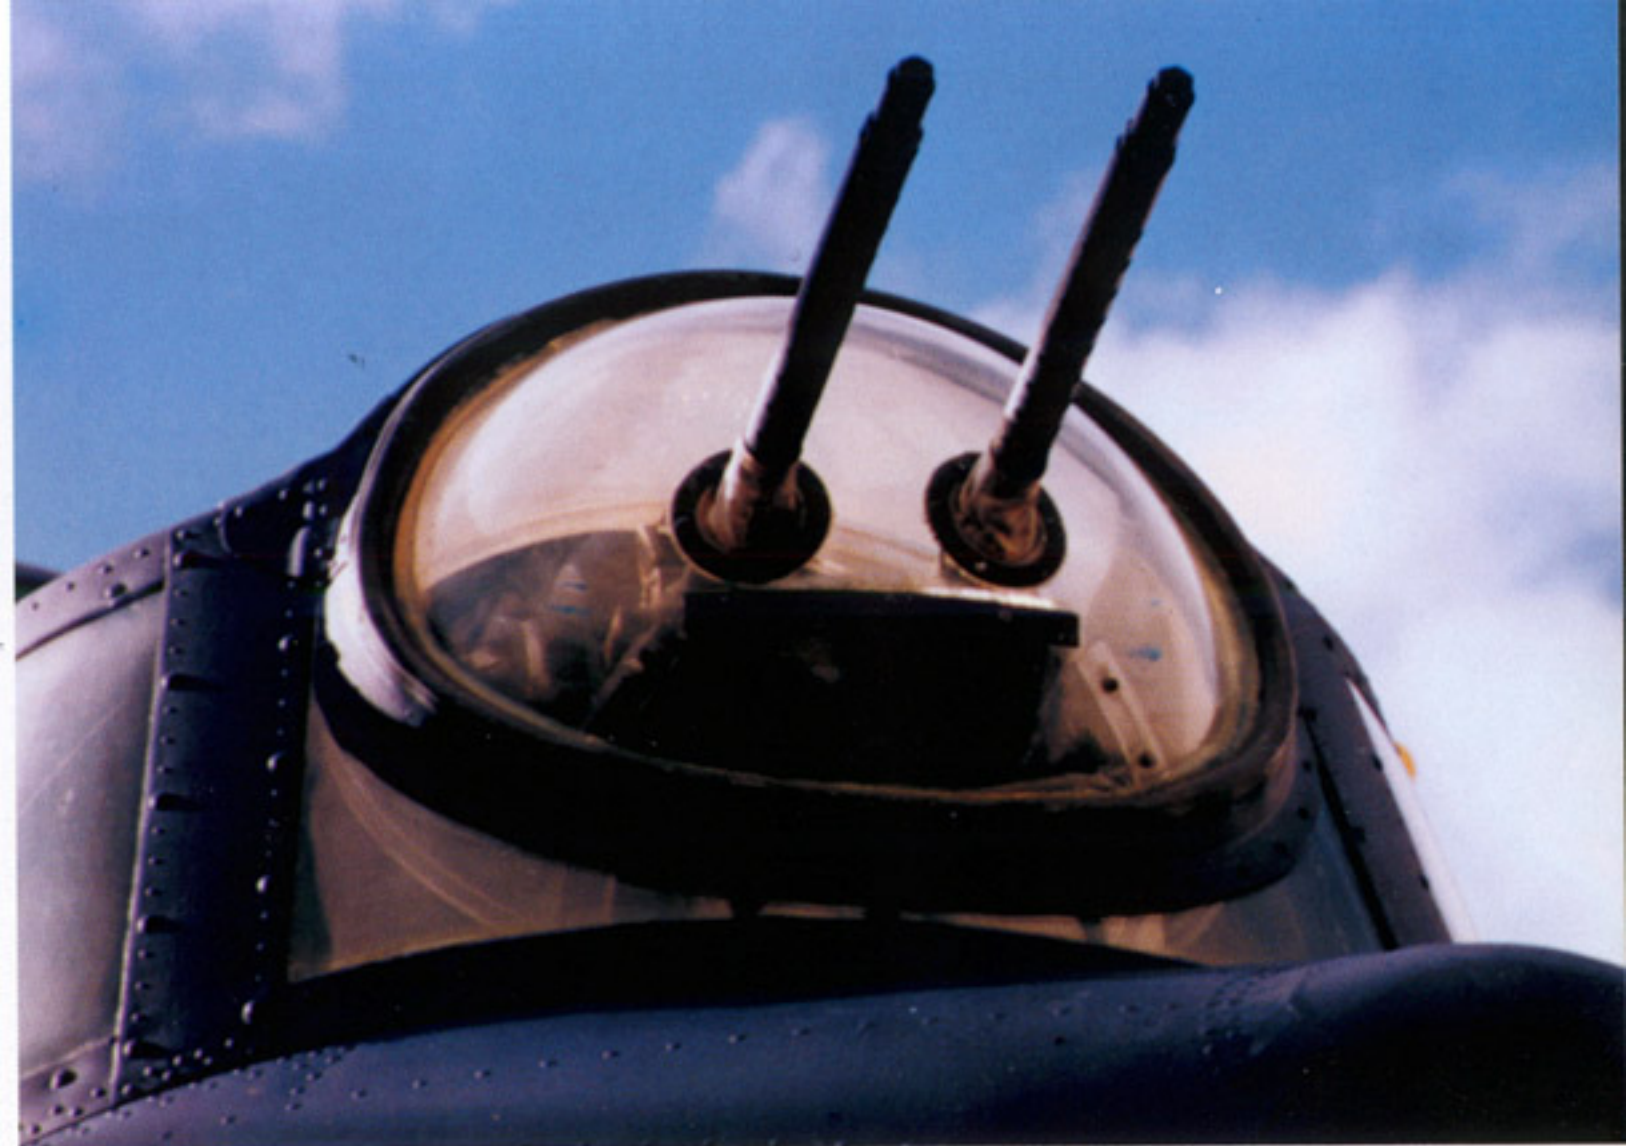
Later PBV-5As had a twin .30 caliber machine gun turret which became known as the "eyeball" turret. This turret greatly improved the gunner's ability to train and aim the twin guns when firing. (Richard Dann)

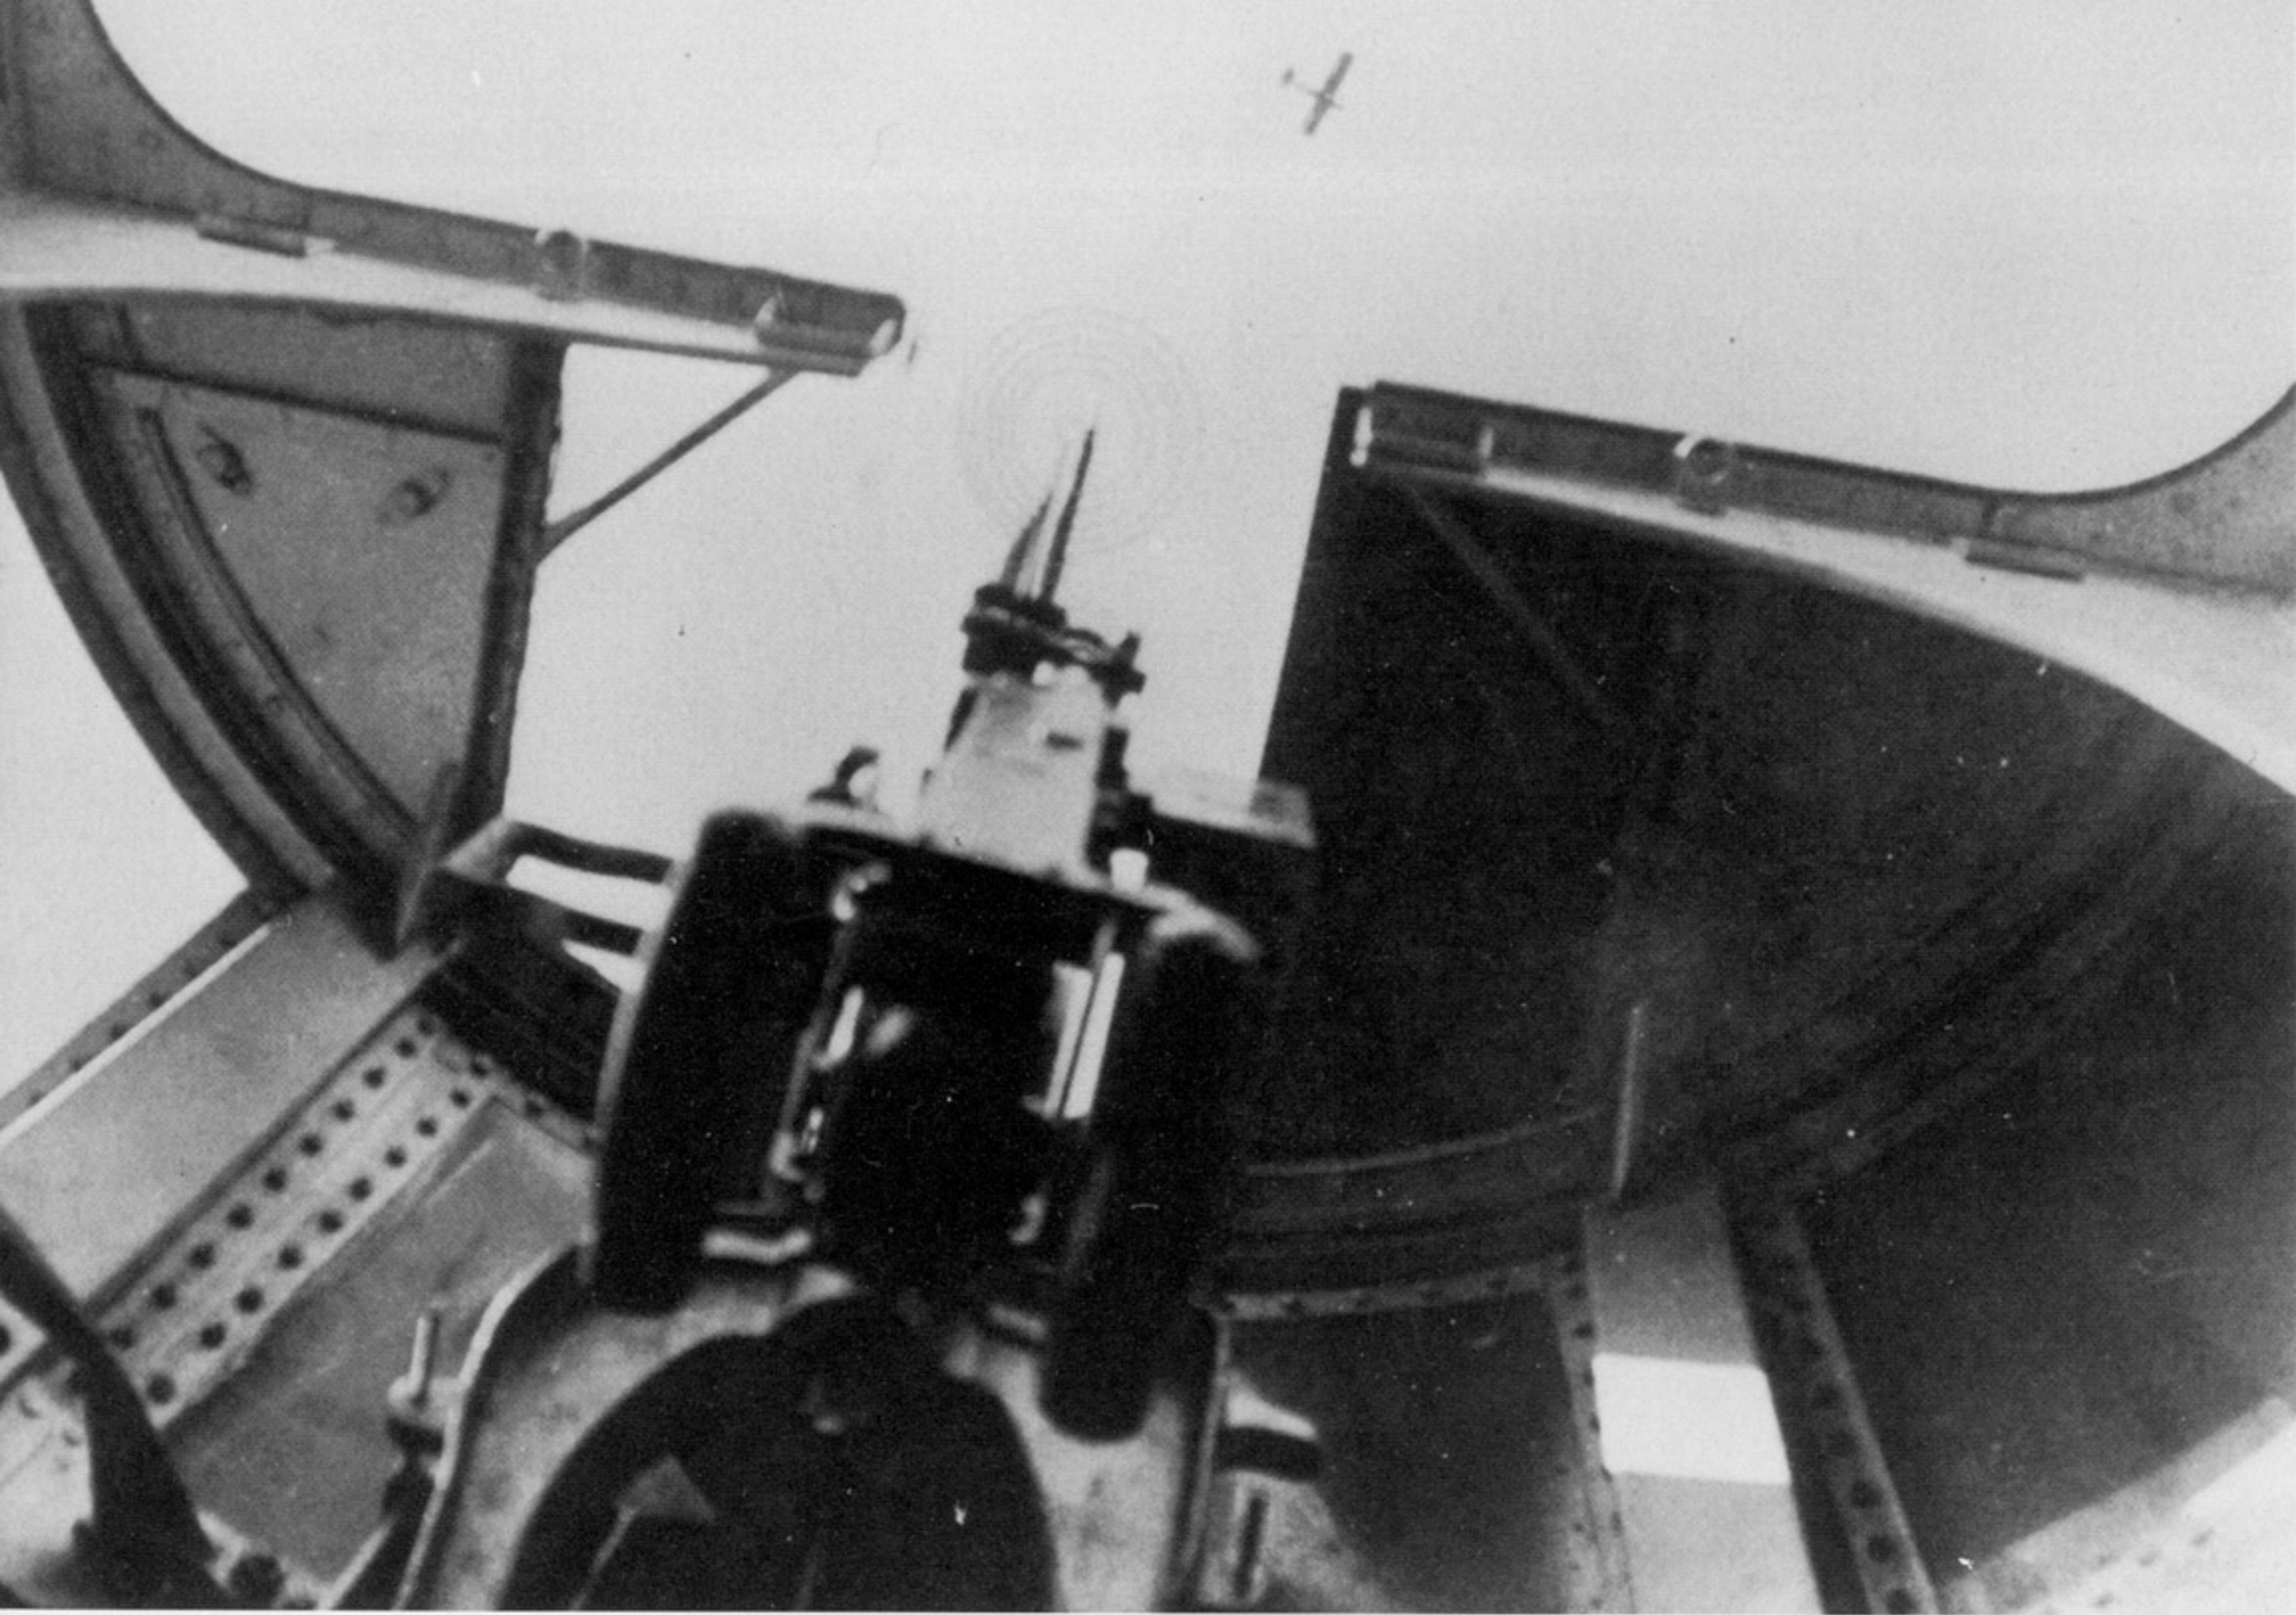
This was the Bombardier/gunner's view through the open top hatch of the bow gun turret of PBY-5 BuNo 2350, of Patrol Squadron Seventy-two (VP-72) during September of 1941.(WES)

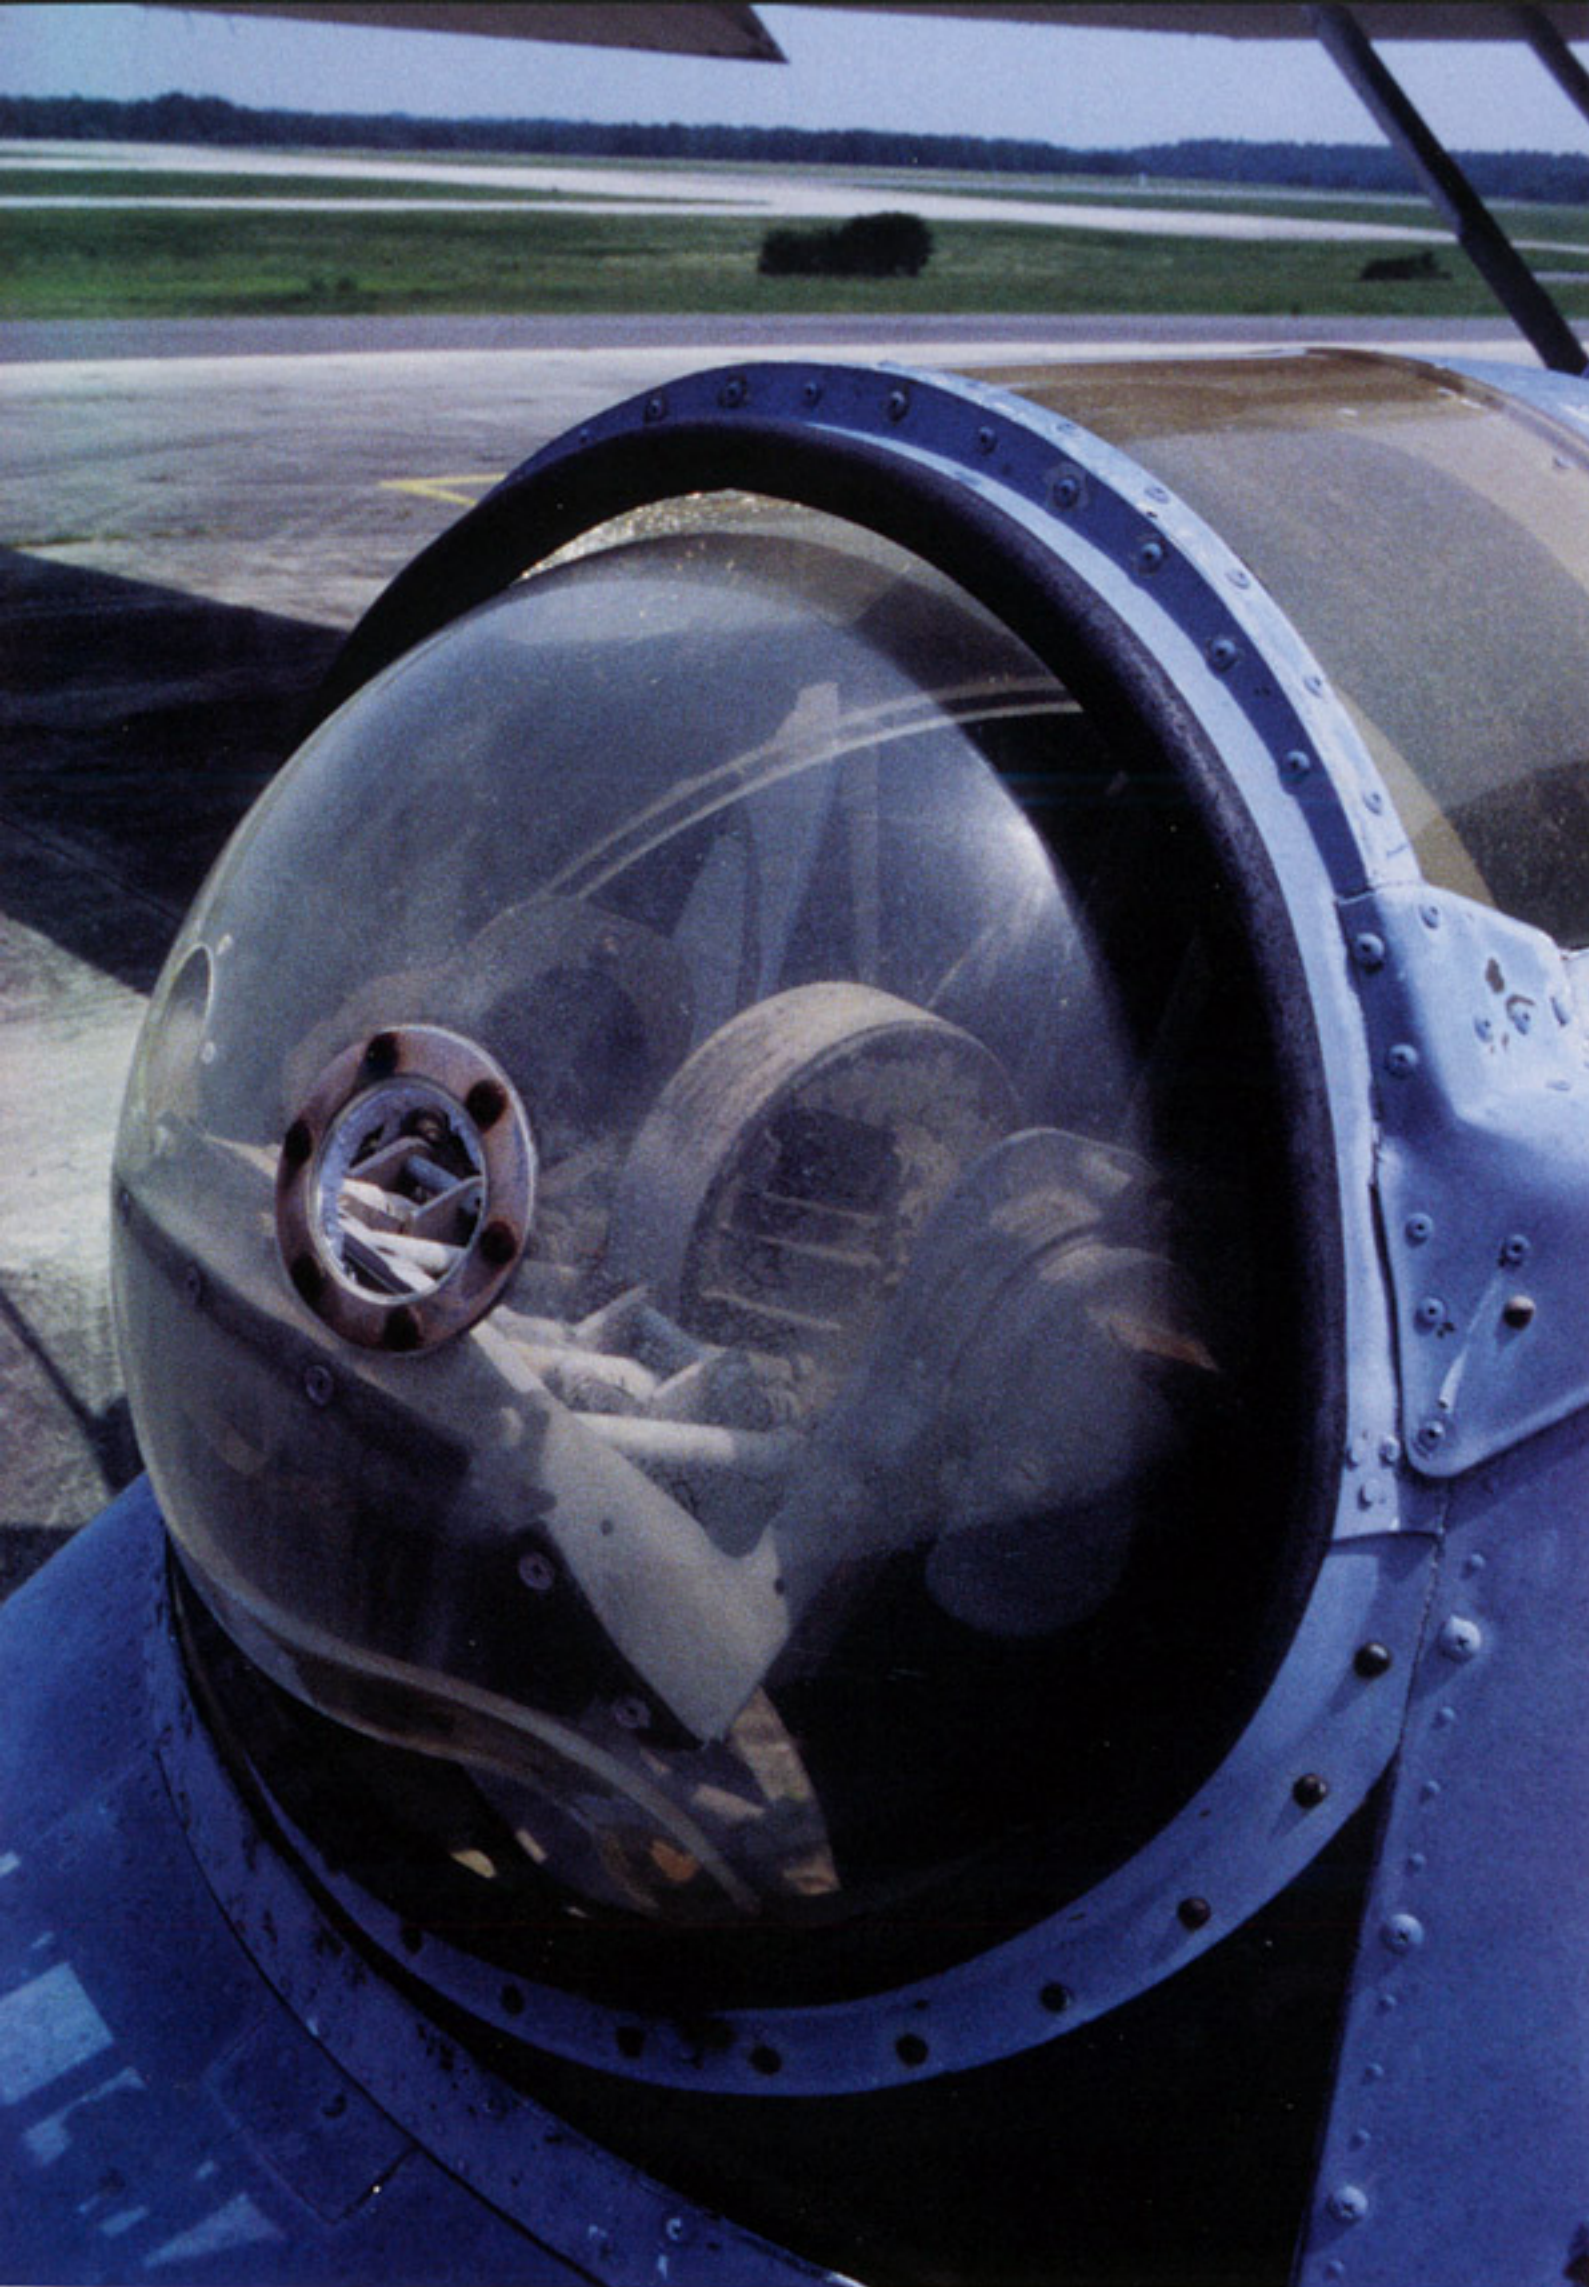
This "eyeball" .30 caliber machine gun turret was removed from a PB4Y and placed on display. The "eyeball" turret had two additional Plexiglas sections, the gun mount sphere and the clear upper dome cover. This mount was a modification of the earlier bow turret and retained the lower turret portion with its multiple windows. This turret was carried by all late production PB4Y variants and was retrofitted to many earlier aircraft as they went through rework. (Mark Aldrich)

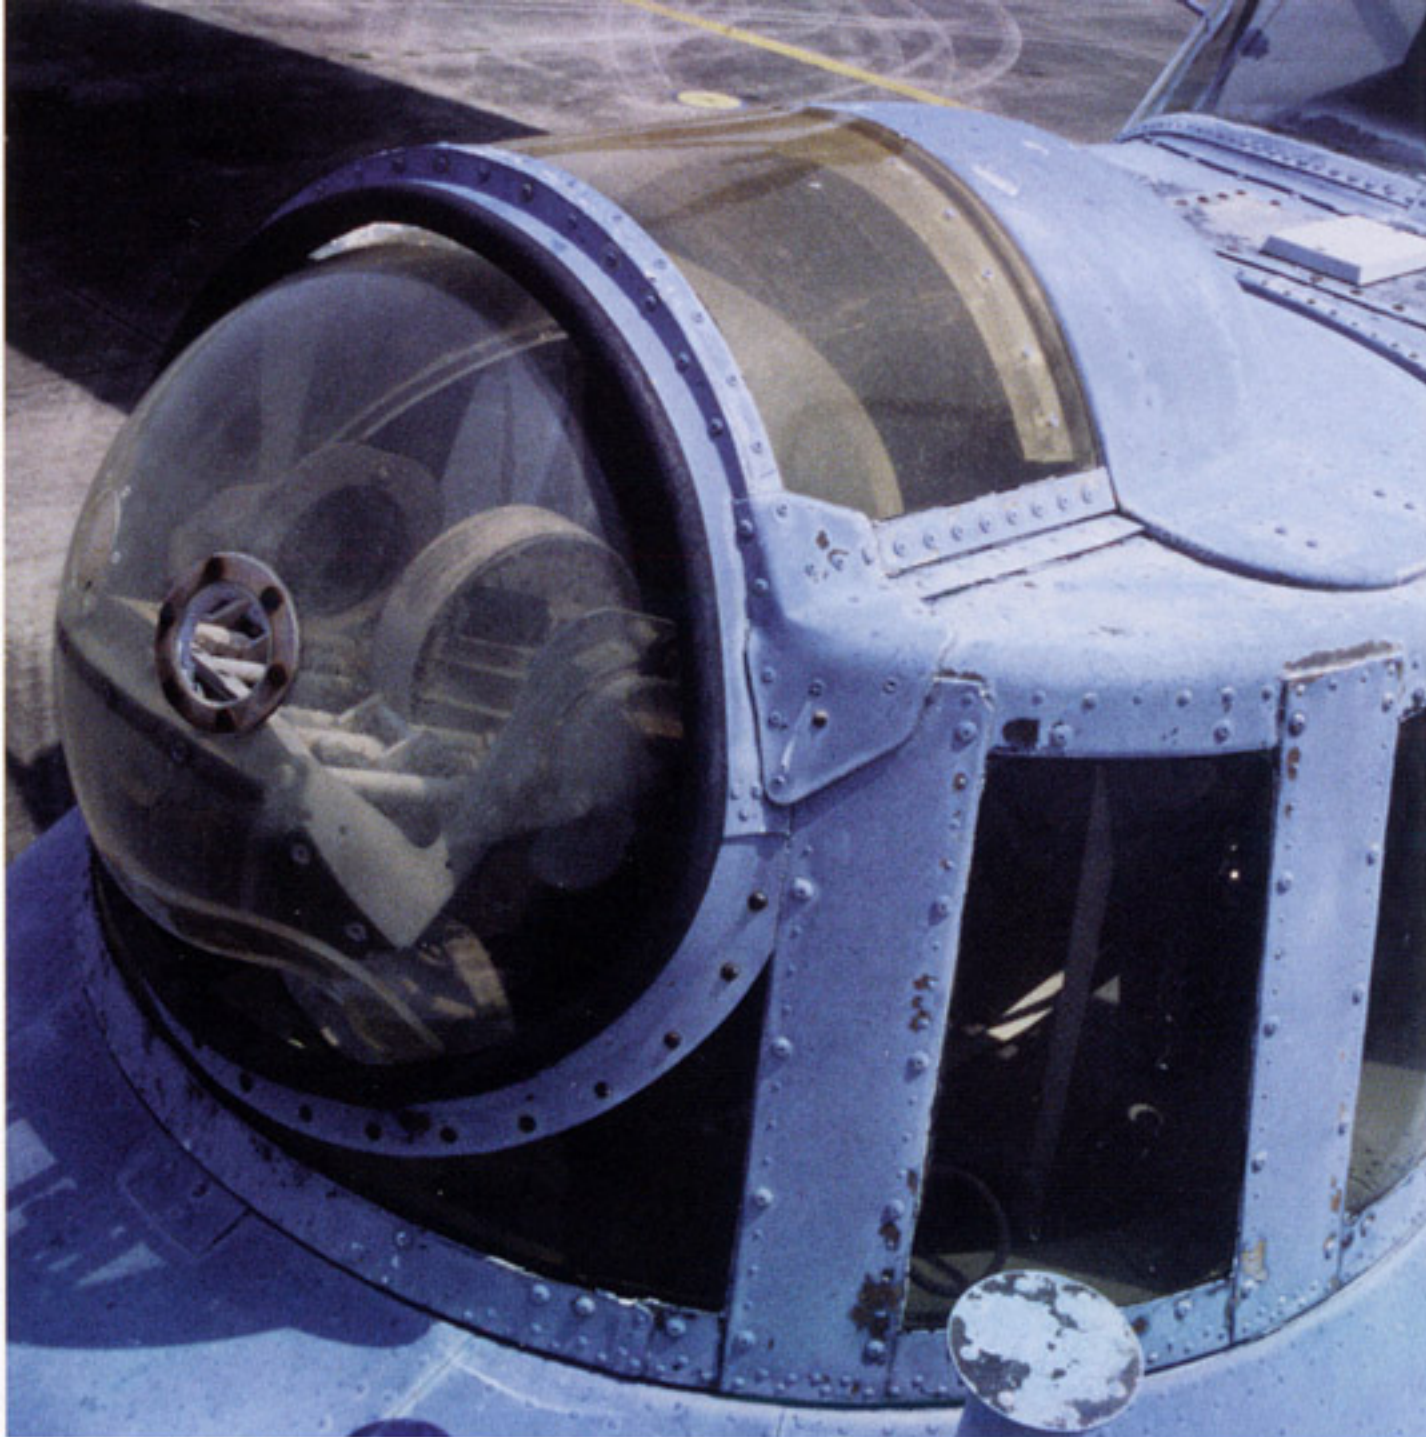
This PBY-5A is in long term open storage at NAS Pensacola, Florida, for future restoration and display. This Catalina has had the bow turret modified at some point in its career, with the gunner's dome being replaced by a sheet metal fairing. The round object at lower right is the top of the removable mooring post. (Mike Bobe)
